Betrifft: BO 208 A2 und A3 BÖLKOW JUNIOR

Teil: Fahrwerksanschlußbeschlag

SERVICE LETTER

Subject: Inspection and Replacement of Main Landing Gear
Attachment Brackets

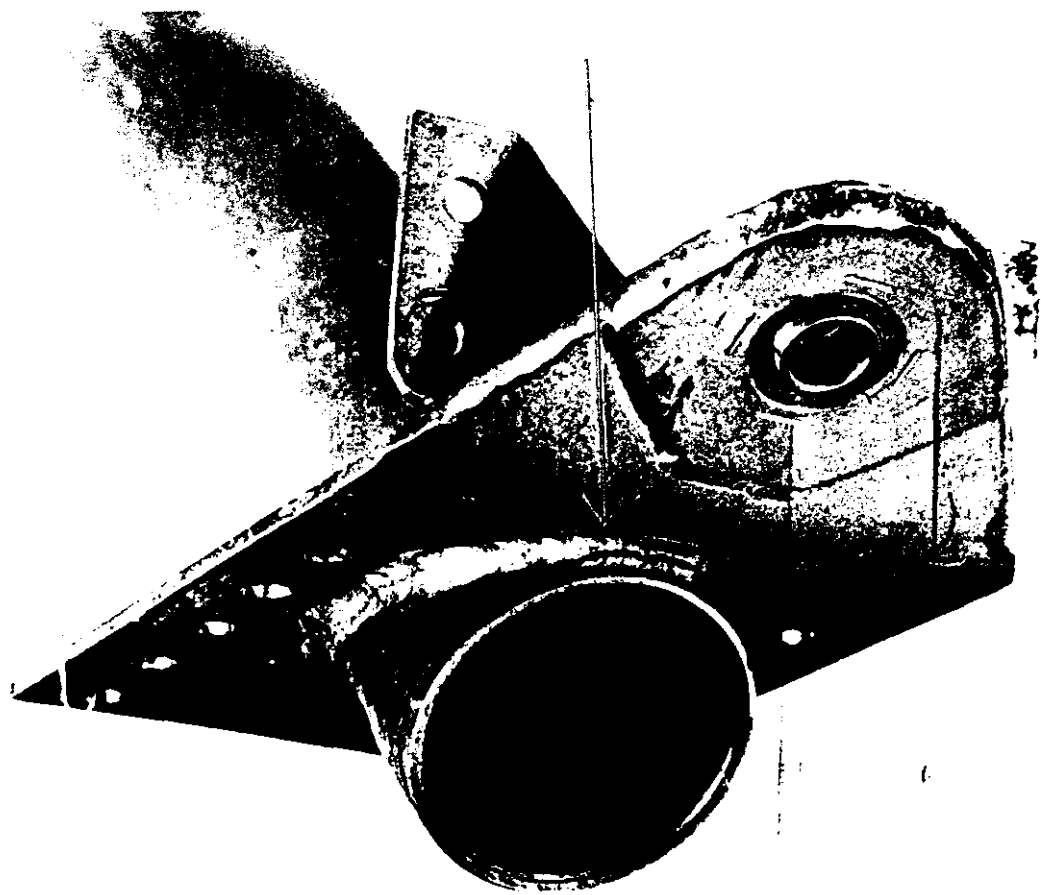
Infolge eines Materialfehlers hat sich leider die Notwendigkeit ergeben, die Hauptfahrwerk-Anschlußbeschläge - selbstverständlich kostenlos - gegen neue auszutauschen. Wir werden Sie daher in absehbarer Zeit bitten, zu diesem Zweck Ihr Flugzeug zu der Ihnen nächstgelegenen Service-Stelle oder in unser Werk Laupheim zu bringen.

Als Sofortmaßnahme bitten wir Sie, die Beschläge an beiden Seiten des Rumpfes vor jedem Fluge daraufhin zu untersuchen, ob sich an der, auf beiliegendem Foto durch einen Pfeil gekennzeichneten Stelle, Risse gebildet haben.

As an immediate precaution, we strongly recommend inspecting the attachment brackets on both sides of the fuselage for possible cracks in the designated areas prior to each flight, as illustrated in the attached photograph.

Sollten sich Risse zeigen, darf die Maschine nicht mehr geflogen werden. Setzen Sie sich in diesem Falle bitte mit Herrn Klier, Werk Laupheim, Telefon (07392) 750 und 751, Telex 07 127 46, in Verbindung.

The airplane must not be flown, if cracks are evident. For advice please contact our Service Manager Mr. Klier at the Laupheim plant. Tel. (07392) 750 or 751, Telex 07 12 746.
