**BÖLKOW GMBH/
WAGGON- UND
MASCHINENBAU AG**

SERVICE-MITTEILUNG

Nr.: 2/67

Beumuster: BÖLKOW BO 208 JUNIOR.

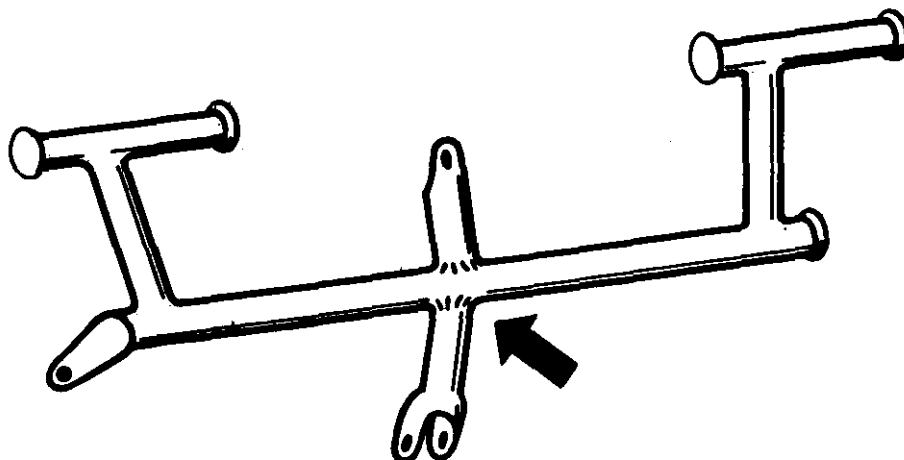
Nach abnormer Beanspruchung der Seitensteuerung beim Rollen wurden bei einem JUNIOR Risse an der Schweißnaht des Gabelhebels für die Bugrad-Stoßstange zum Querrohr der Seitensteuerpedale festgestellt (siehe Skizze).

Prüfen Sie bitte anlässlich der nächsten Kontrollen die bezeichnete Stelle auf Rissbildung und wechseln Sie ggf. das betreffende Pedal gegen ein neues (vom Werk bereits verstärktes) Pedal aus.

Darüber hinaus empfehlen wir, die verstärkten Pedale auch dann einzubauen, wenn an den bisherigen noch keine Risse festzustellen sind.

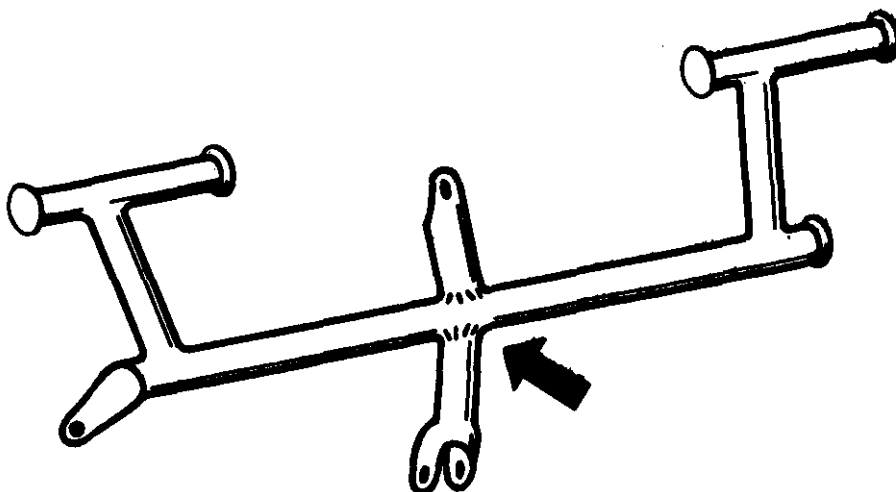
Following abnormal loading of the rudder during rolls, cracks were discovered on a JUNIOR on the weld of the fork lever for the nosewheel push rod to the cross tubes of the rudder pedals (see sketch).

Please check on the occasion of the next inspections the given spot for cracks and if necessary, change the pedal in question for a new pedal (already reinforced in the factory).

We also recommend installing the reinforced pedals even if no cracks are to be discovered on the pedals presently installed.
